WAYNE K. ROSS, M.D., P.C.
Specializing in Forensic and Neuropathology

RE: Chad McCune and Carmen McCune, et al. v. Graco Children's Products, Inc., et al (C10-032)

INJURY CAUSATION ANALYSIS:

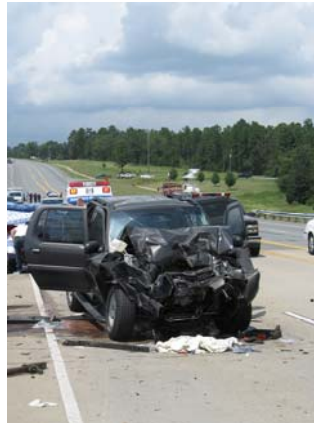
This is a frontal view of the damage to the Ford Explorer.

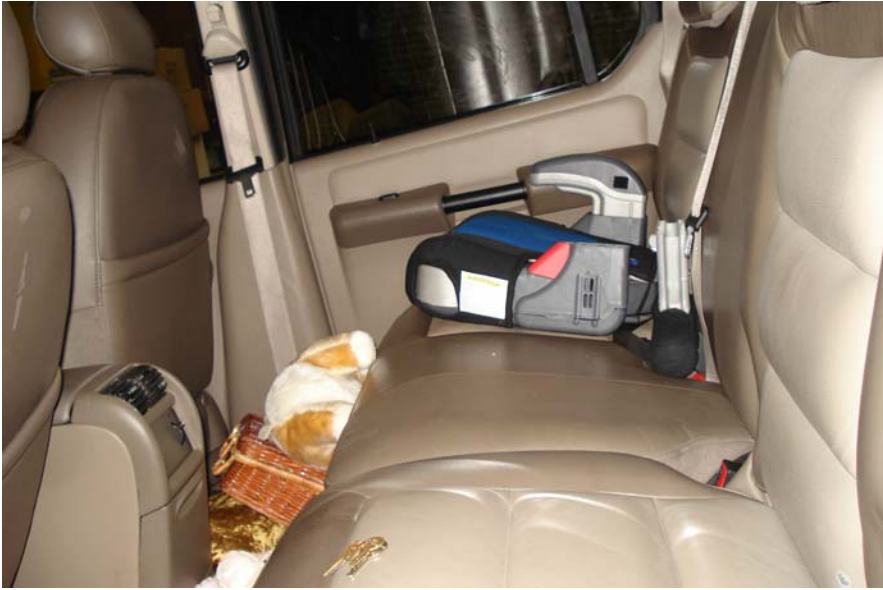
This is a view from the driver's side showing the booster seat in the rear passenger compartment. The front passenger seat is positioned before the B pillar. The left arm rest is dislodged from the seat.

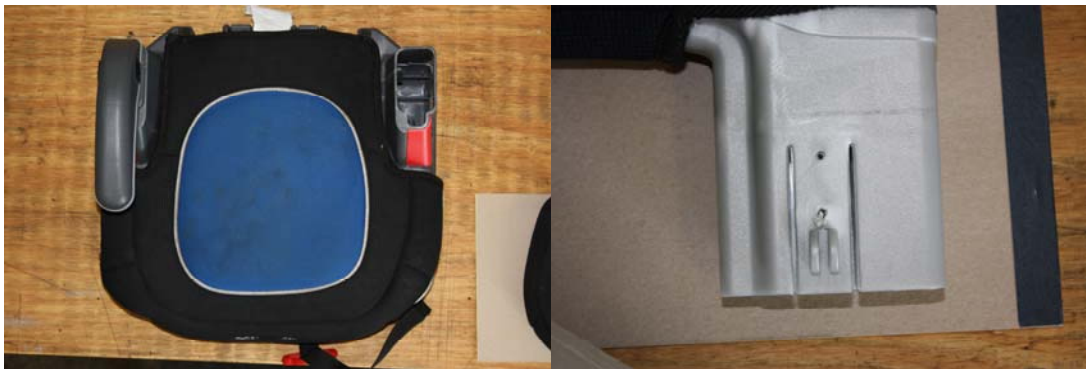
Graco Booster Seat

We also received a Graco Turbo Booster, model 8491RGB, serial #JJ0402050720415. It was received in bubble wrap. Examination of the booster seat shows that the left arm rest is dislodged and displaced. Multiple photographs are obtained of the arm rest out of its position as well as near the area where it was displaced. The arm rest is intact. Abrasions are observed overlying the routing area, which represents the area of seat belt placement.

The left arm rest shows a scuff mark to the under surface of the cover. There are multiple areas of white discoloration representing stress to the plastic and the area in which the front side screw was placed shows evidence of damage. Comparison is made to the right arm rest where the front side screw is still in place.

The left side base top and bottom are separated upon examination. The tab has been disarticulated and identified outside the lower base. Stress marks are observed to the seat base.

Dissociated Left Arm Rest

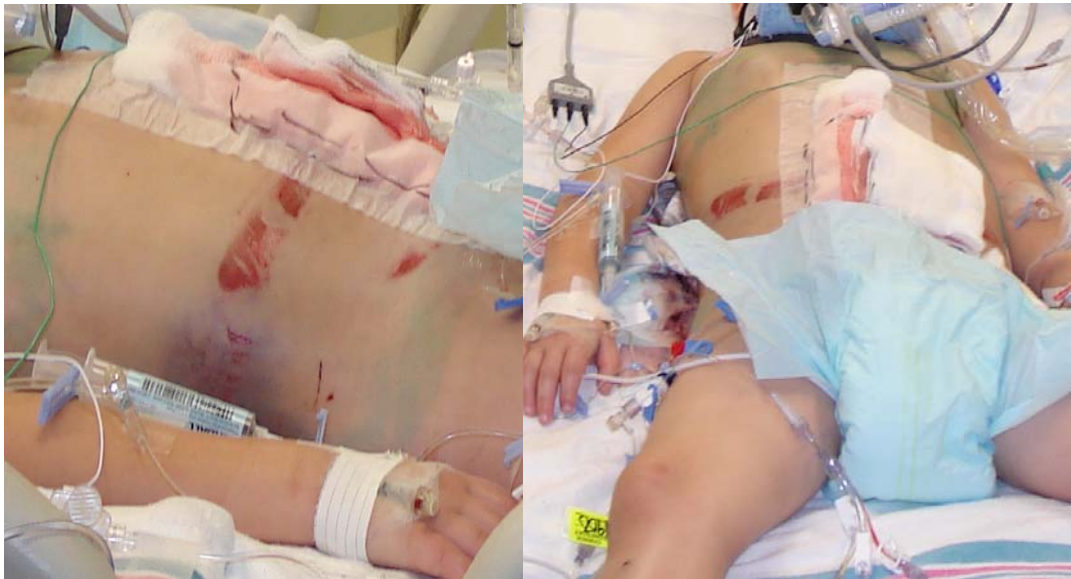
The first photograph shows a lap belt mark on the pelvis and shoulder belt mark on the abdomen and the right forearm. The second photograph shows a shoulder belt mark on the abdomen and the right forearm.

The injury pattern to the abdomen is to the right mid quadrant and the left mid lower quadrant indicative of the torso belt. The right mid quadrant wound shows a band-like abrasion pattern with the bruise pattern prominently identified from the anterior axillary line to the posterior axillary line along the right posterior lateral abdomen. The wound angulated downward to Jason's left as observed in the abdominal photographs. The reverse of that pattern would be that the wound ascends upward along the right side of the abdomen and along the right lateral abdominal wall. That pattern is primarily an abraded pattern which indicates frictional movement between the body and the belt. The lateral abdomen shows evidence of a friction abrasion with a bruise pattern more prominent noted posteriorly. The friction abrasion shows movement between the body and the belt and the bruise pattern shows blunt force impact but, obviously, less movement between the body and the belt itself; although there is a conjoining area of abrasion in the area. Although difficult to observe, there is an abrasion pattern noted to the left quadrant of the abdomen. The angle of that pattern is reconstructed with the overall pattern of the wound and the two are conjoining.

A mark/bruise is observed to the right distal forearm. There are two transverse marks. There is an intervening blanched area. In addition, the blanched area has two circular bruises to the right forearm.

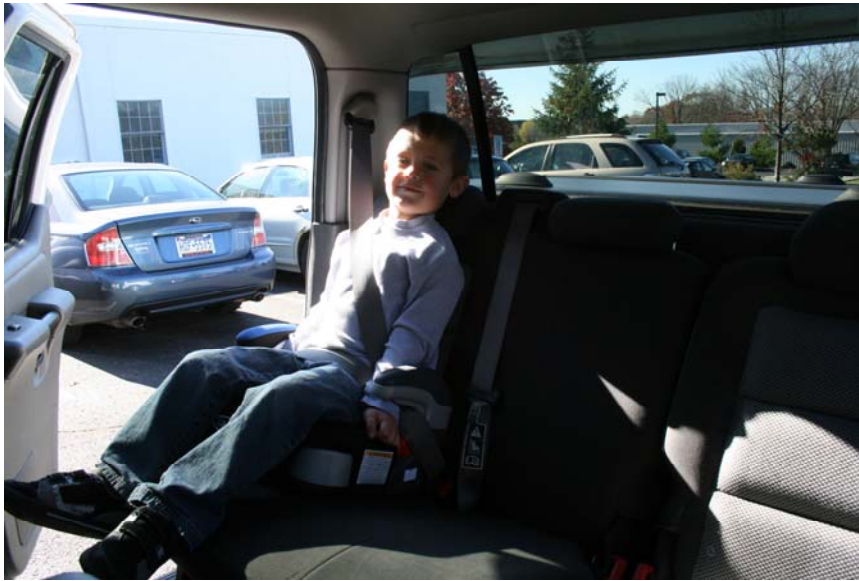
In this position – **should he not rotate out of the belt** – one would expect a diagonal belt pattern extending upward from the lower abdomen to the right upper region of the chest. (This is confirmed by the surrogate who shows the pre-impact position with the orientation of the lap-shoulder belt restraints.) The pattern could be a bruise or abrasion pattern. In many cases, the pattern is primarily a bruise pattern. Bruises represent blunt force engagement injuries that result in hemorrhages to the skin or beneath the skin. Patterns are diagonal because of the implementation of the shoulder belt diagonally over the body. Thus simply stated, engagement of a diagonal belt in a diagonal fashion over the body would leave diagonal injuries. Typically speaking, the injuries may be present to the abdomen, chest, or the right shoulder region. The lap belt functions to engage the pelvis and the shoulder belt functions engaging the pelvis-sternum-right shoulder. Because these areas are of bone and since they are more durable in withstanding forces from the ride down they represent points of contact for seat belt engagement. So the following analysis is meant to compare the belt marks at the hospital with those expected should the belt stay on the pelvis and shoulder.

Surrogate with lap and shoulder belt.

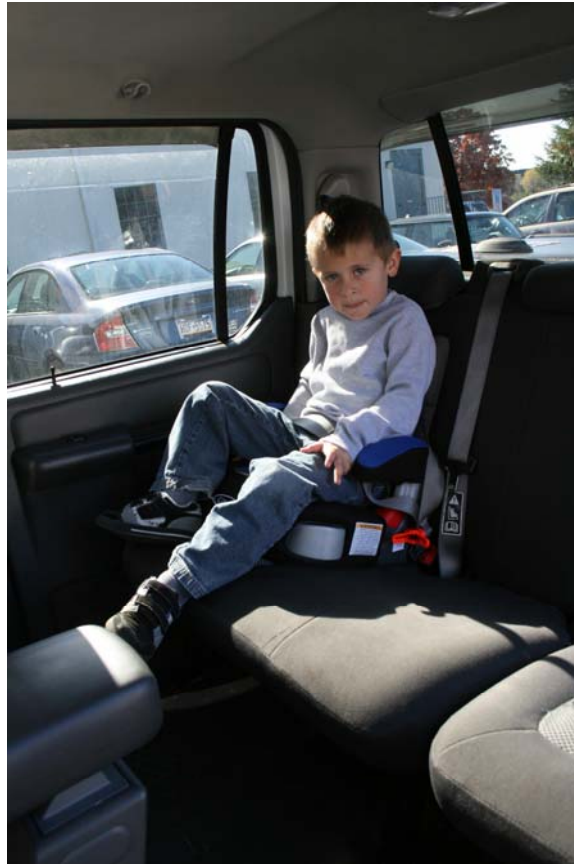
Hypothetical argument # 3: Jason was seated facing forward in the booster seat with the lap belt positioned over his hips but the torso belt was positioned behind his back and, in addition, it was positioned over the left arm support.

Seat belt over the arm rest and behind his back.

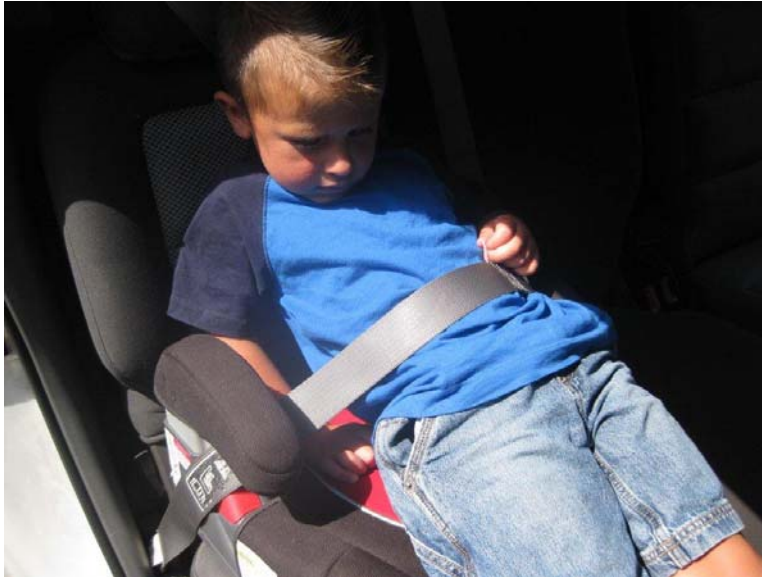
because of the unimpeded process and lack of ride-down due to absence of the shoulder belt. Once the pelvis engages the belt, marks would be made to the front of the pelvis. Photographs of Jason depict an abrasion to the right inguinal region compatible with a lap belt impression. However, in this scenario the body of Jason would continue to move because of the lack of upper body restraint and would slide underneath the lap belt. As noted in the surrogate photographs, the upper body would necessarily slide underneath the lap belt with the final resting place of the lap belt to the upper torso region.

Shoulder belt behind surrogate. Surrogate submarining under lap belt.

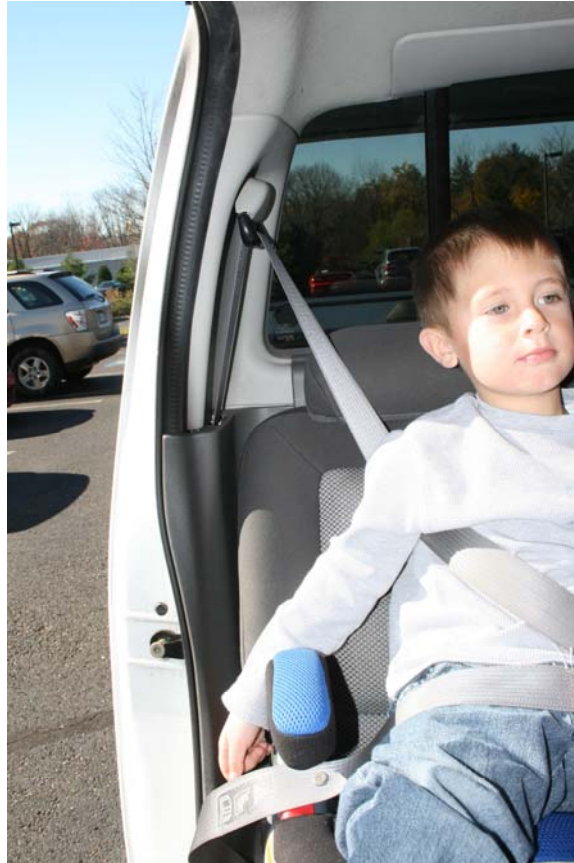
Seat belt under the arm rest and under his right arm pit.

In this scenario the shoulder belt would be positioned diagonally across the chest and abdomen and configured underneath the right armpit positioned underneath the arm and upward behind Jason. Thus the lap belt could lead to abrasions to the right inguinal region. If the belt is positioned under the right arm, it would be diagonal across the abdomen and chest. The surrogate illustrates the position of the belt. In this scenario the belt would engage the upper abdominal / chest region and result in rib fractures, liver injury, hemorrhage to the chest, lung and / or cardiac injury. None of these injuries were appreciated in the medical record or radiographic scans. The photographs of Jason at the hospital depict a shoulder belt mark which is down low on the abdomen. No belt marks are appreciated under the arm pit or across the chest. Lastly, one must examine the upper extremities of Jason to further characterize the configuration of the shoulder belt prior to impact.

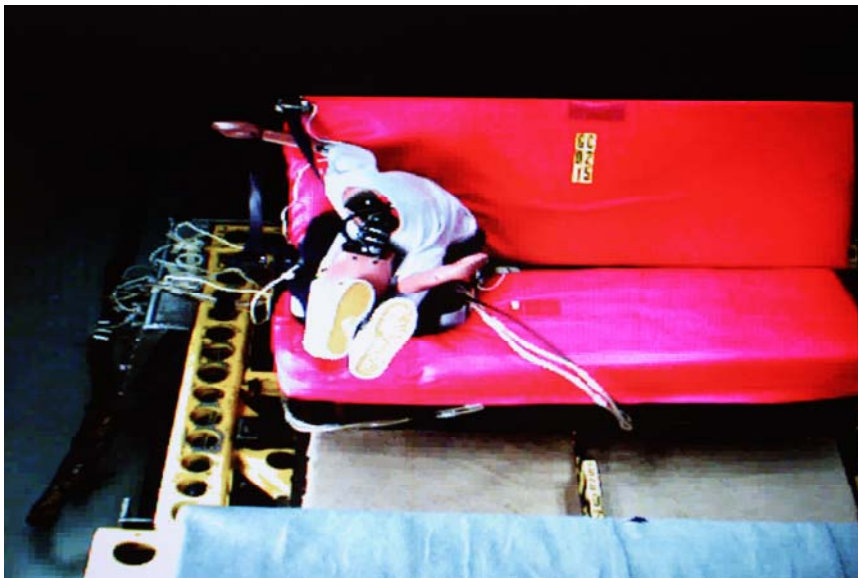
Test: GC0215

Lastly, the sled tests performed by Graco also supports this contention and the physical evidence. Sled tests are performed during a frontal impact and during side impact. Early in the sled tests the dummy rolls out of the shoulder belt. This occurs even before the arm rest dislodges. In the other tests the arm rest comes off early. The shoulder belt pulls up on the arm rest and it comes off early in the crash pulse.

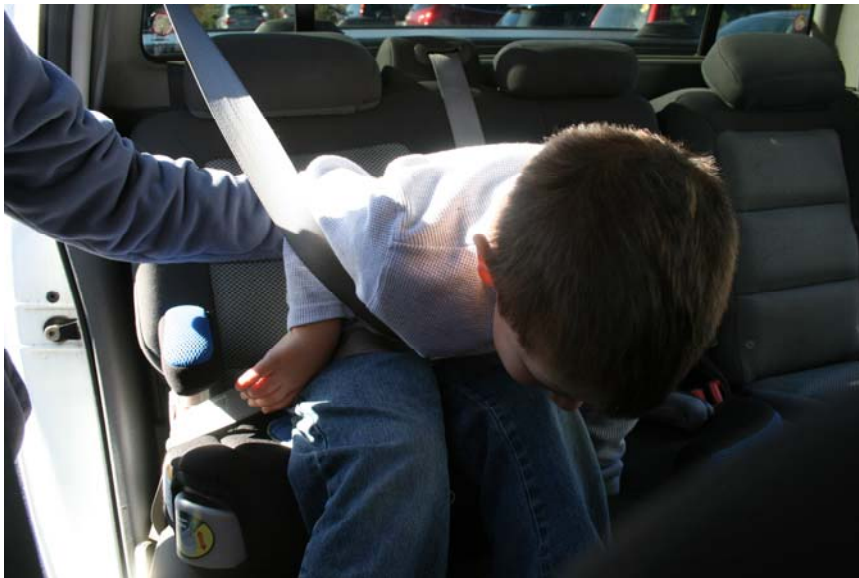
Hypothetical argument #5: Jason was positioned in the seat facing forward with the lap belt appropriately positioned over his hips and the torso belt diagonally positioned over his right shoulder. But during the accident the shoulder belt reconfigured low on his abdomen and around his forearm.

Surrogate analysis: Notice the position of the shoulder belt on the abdomen and around the right forearm.
